RE: Draft White Paper on TVA's Kingston Ash Failure

BY: Barry Thacker, P.E.
barryt@geoe.com

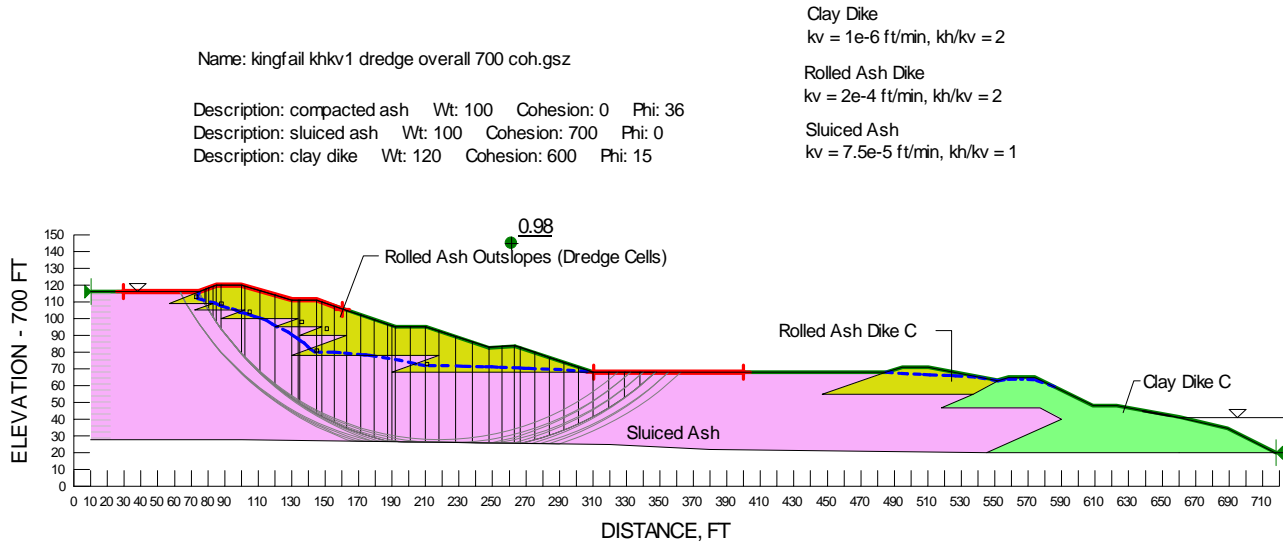
Figure 1 shows the results of a stability analysis that back-calculates average undrained shear strength = 700 psf for the sluiced ash and ash/sediment layer as being required to produce a factor of safety less than 1.0. Figure 2 illustrates that a zone at the base of the sluiced ash with undrained shear strength = 600 psf could produce failure presuming the overlying sluiced ash has undrained shear strength = 725 psf.

Figure 1. Results of stability analysis for undrained shear strength of sluiced ash = 700 psf and minimum factor of safety less than 1.0 according to the undrained failure theory suggested by TVA's forensic team at Kingston

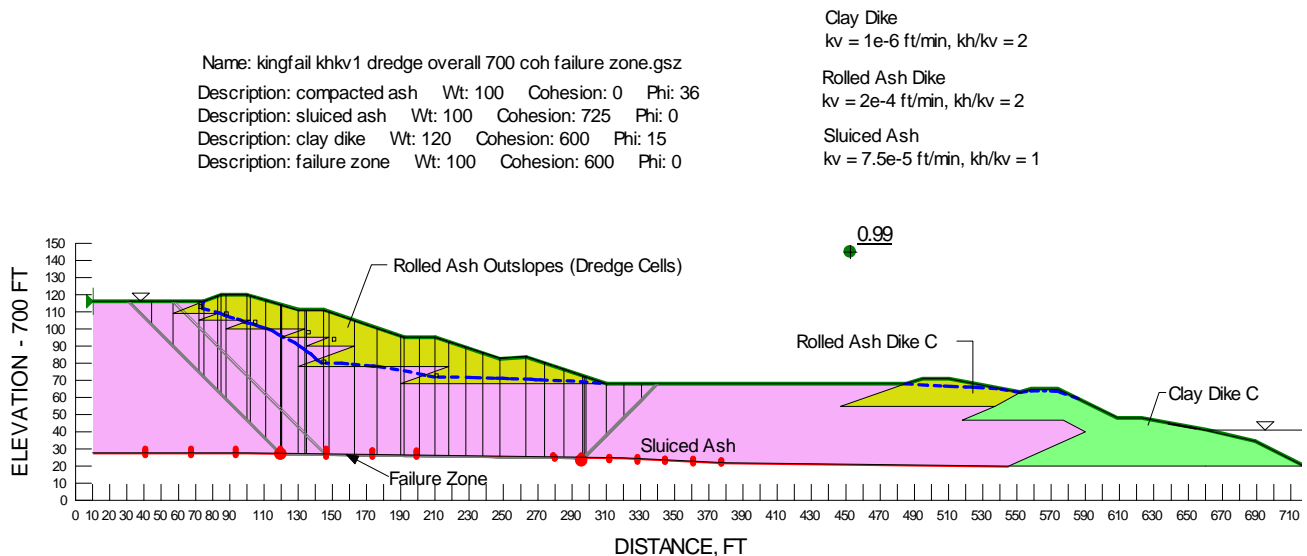
Figure 2. Results of stability analysis for weak bottom layer having undrained shear strength = 600 psf, remaining sluiced ash having undrained shear strength = 725 psf, and minimum factor of safety less than 1.0 according to the undrained failure theory suggested by TVA's forensic team at Kingston

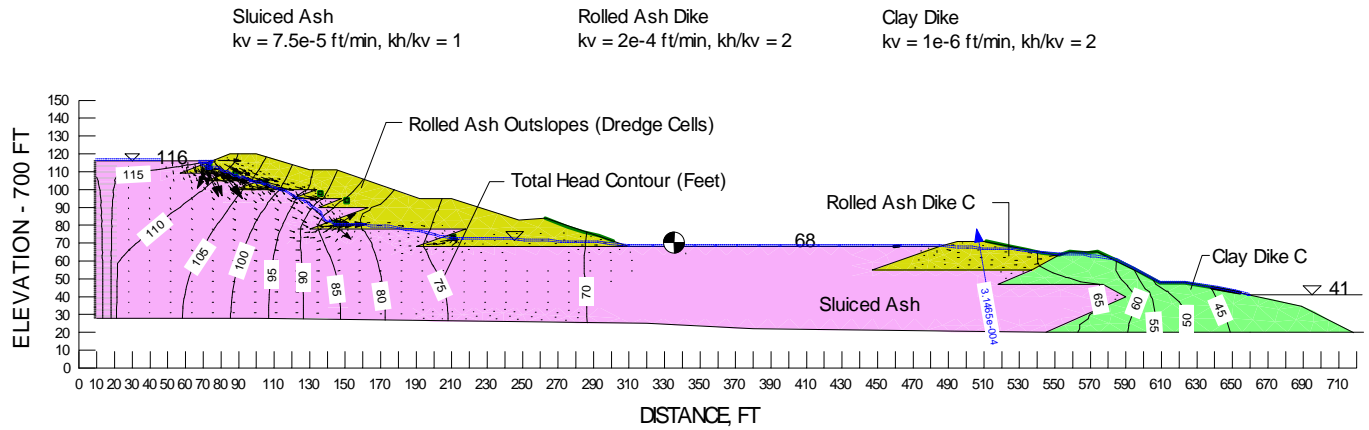
Figures 3, 4, and 5 present the results of finite element seepage modeling for k_h/k_v in the sluiced ash of 1, 10, and 100, respectively. Figures 6, 7, and 8 illustrate that, even at k_h/k_v equal to 100 in the sluiced ash, failure of the northeastern outslope of the dredge cells at Kingston is not predicted. The modeling indicates that the extensive internal drains installed since 1984 provide a stable embankment under normal operating conditions.

Figure 3. Results of finite element seepage analysis for northeast outslope of Kingston Dredge Cells and Dike C with $k_h/k_v = 1$ in sluiced ash

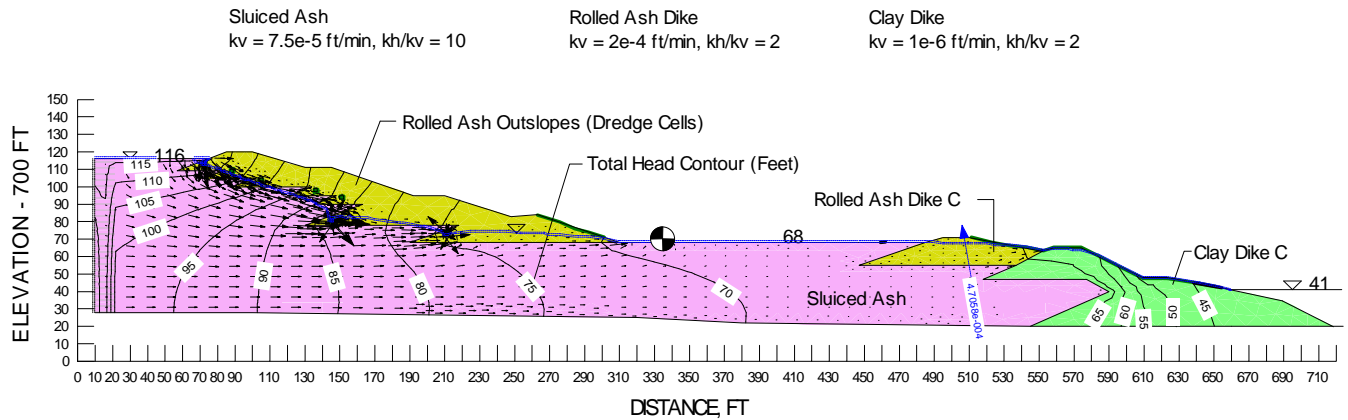
Figure 4. Results of finite element seepage analysis for northeast outslope of Kingston Dredge Cells and Dike C with $k_h/k_v = 10$ in sluiced ash

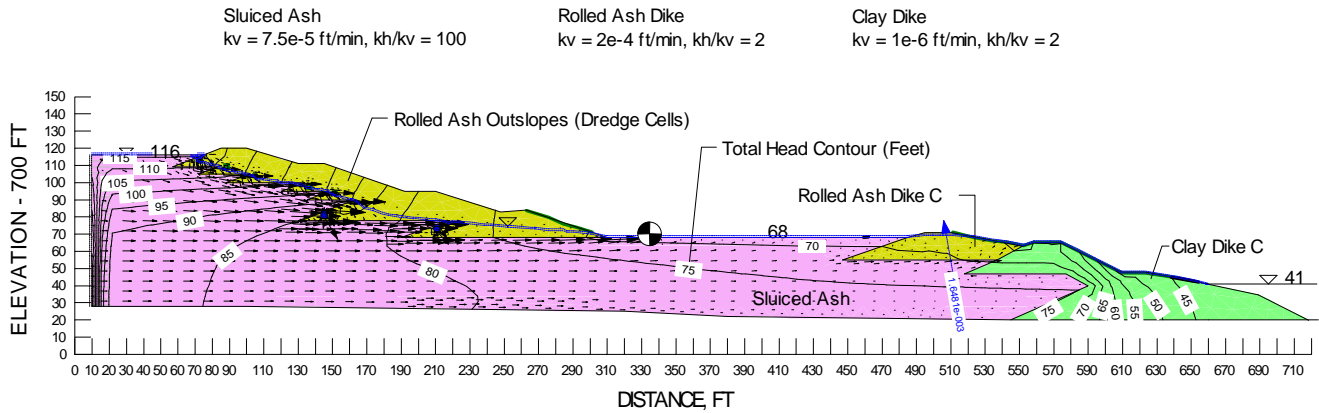
Figure 5. Results of finite element seepage analysis for northeast outslope of Kingston Dredge Cells and Dike C with $k_h/k_v = 100$ in sluiced ash

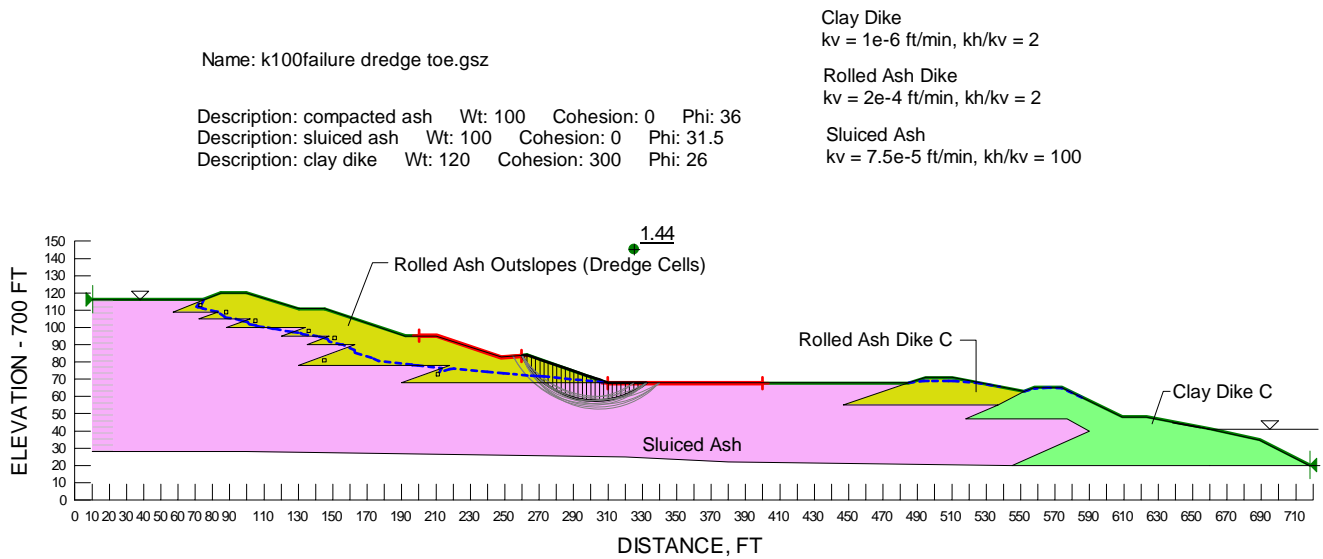
Figure 6. Results of stability analysis for effective stress condition with $k_h/k_v = 100$ in sluiced ash and minimum factor of safety = 1.44 (for lower toe of northeast outslope of Kingston Dredge Cells)

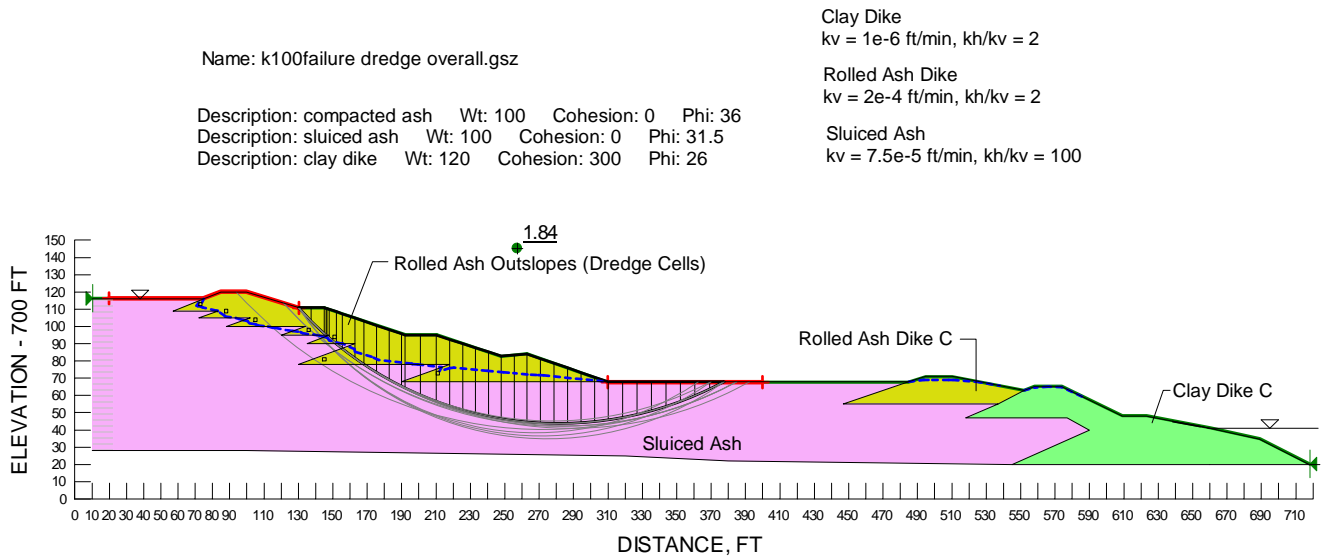
Figure 7. Results of stability analysis for effective stress condition with $k_h/k_v = 100$ in sluiced ash and minimum factor of safety = 1.84 (for mid-height to full-height case of northeast outslope of Kingston Dredge Cells)

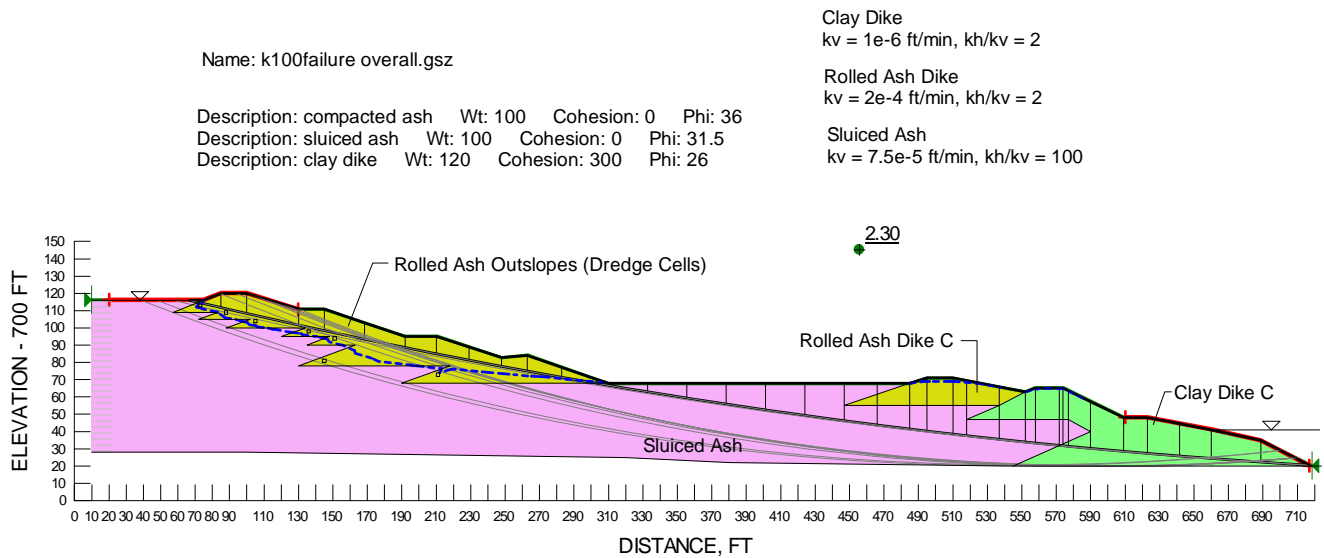
Figure 8. Results of stability analysis for effective stress condition with $k_h/k_v = 100$ in sluiced ash and minimum factor of safety = 2.30 (for full-height case of northeast outslope of Kingston Dredge Cells and Dike C)

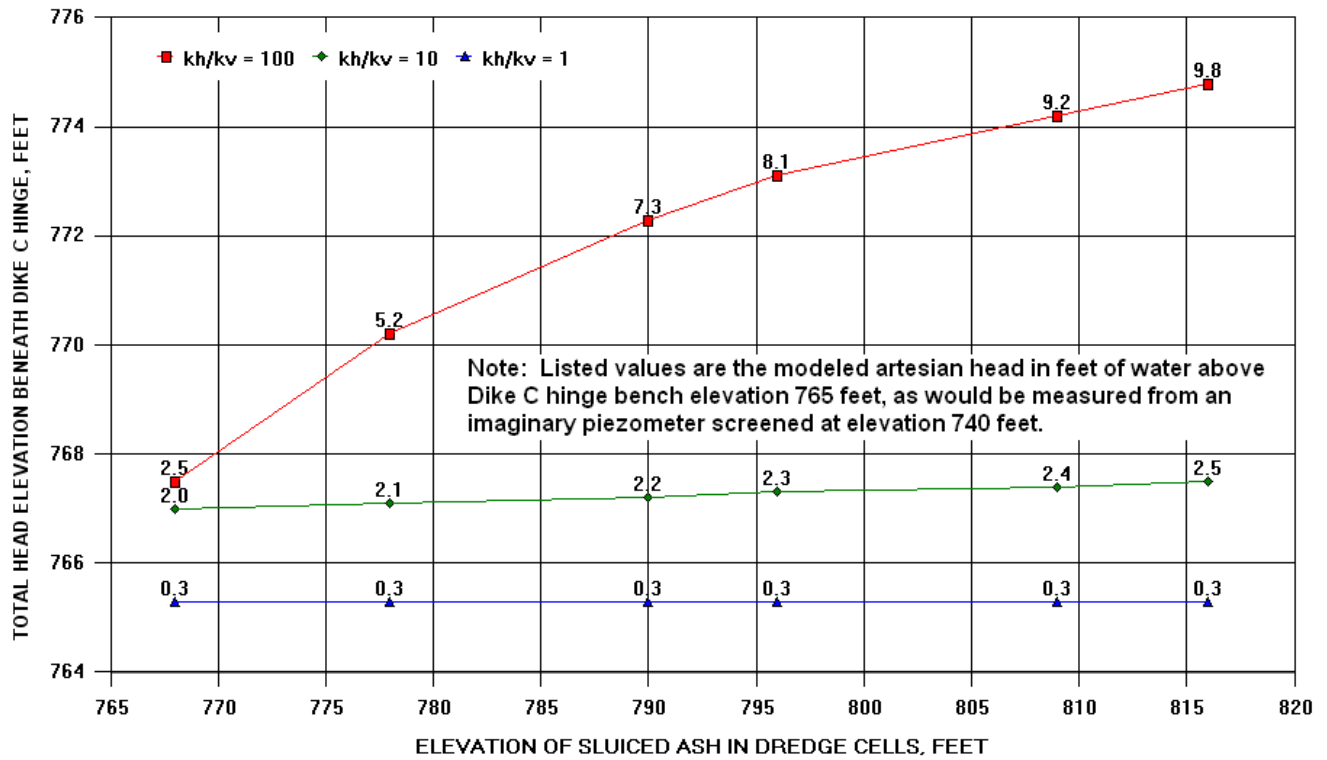
The problem area appears to be Dike C, which was built beginning in 1958 with no apparent internal drains, but with a hinge zone in the area of the original earthen dike crest and its first raising. Modeling shows the potential for high artesian pore water pressures to exist in the sluiced ash beneath Dike C during steady-state seepage conditions. Specifically, the relationship between sluiced ash elevation and total water head elevation in the area of the Dike C hinge, for various k_h/k_v conditions, is shown on Figure 9. Computed artesian heads are also presented on Figure 9 for an imaginary piezometer installed from the Dike C bench at elevation 765 feet and screened in the sluiced ash at elevation 740 feet.

Figure 9. Results of steady-state seepage modeling, with k_h/k_v in sluiced ash ranging from 1 to 100, showing computed total water head elevations in sluiced beneath Dike C hinge area and artesian heads above the Dike C hinge bench at elevation 765

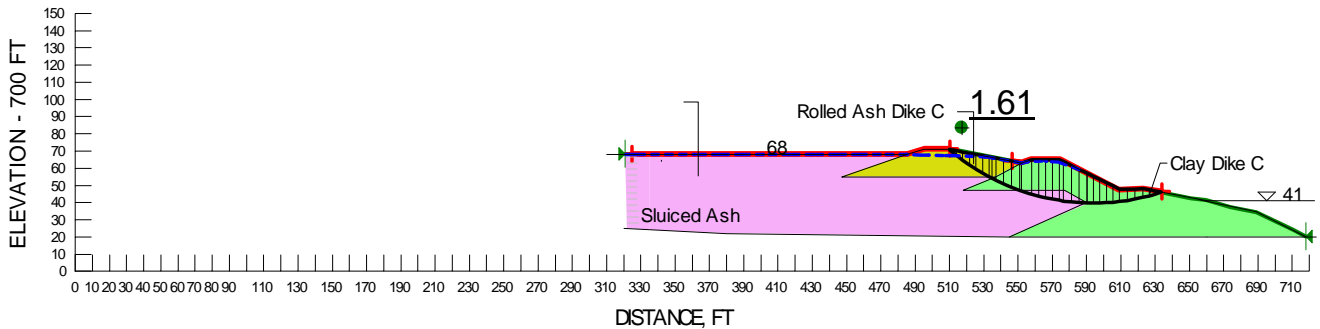
With regard to stability, a computed factor of safety greater than 1.5 is predicted in the hinge area of Dike C prior to construction of the dredge cells, when the level of the sluiced ash is at elevation 768 feet, as shown on Figure 10. When the sluiced ash in the dredge cells is at elevation 809 feet in the model, the computed factor of safety of Dike C is slightly greater than 1.0 as shown on Figure 11 and failure is still not predicted; however, when the sluiced ash reaches elevation 816 feet in the dredge cells, as it did on 22 December 2008, the model accurately predicts failure with a factor of safety less than 1.0 as shown on Figure 12.

Figure 10. Results of stability analysis for effective stress condition with $k_h/k_v = 100$ in sluiced ash and minimum factor of safety = 1.61 for Dike C hinge area (for case with sluiced ash elevation = 768 feet before construction of Kingston Dredge Cells)

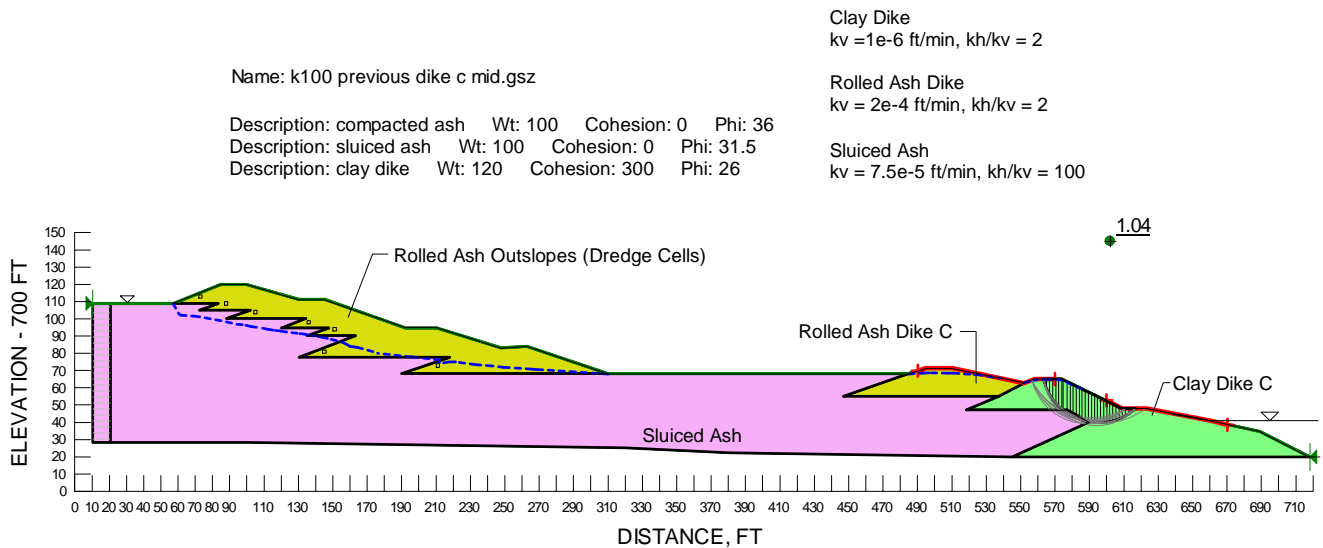
Figure 11. Results of stability analysis for effective stress condition with $k_h/k_v = 100$ in sluiced ash and minimum factor of safety = 1.04 for Dike C hinge area (for case with sluiced ash elevation = 809 feet in Kingston Dredge Cells)

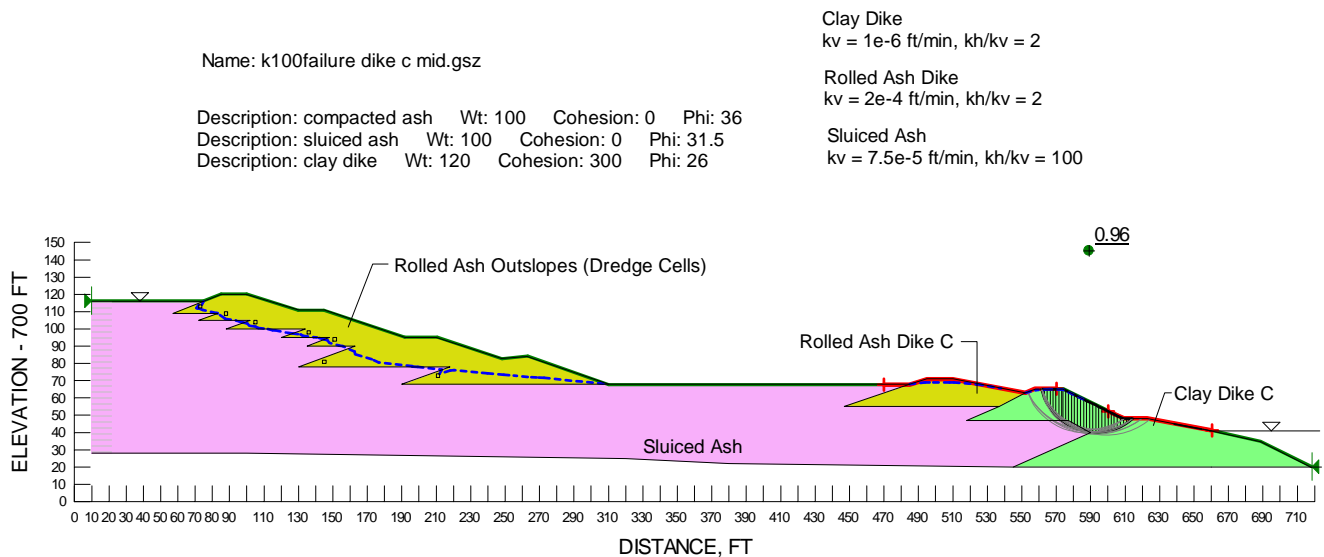
Figure 12. Results of stability analysis for effective stress condition with $k_h/k_v = 100$ in sluiced ash and minimum factor of safety = 0.96 for Dike C hinge area (for case with sluiced ash elevation = 816 feet in Kingston Dredge Cells, which coincides with condition at the time of failure on 22 December 2008)

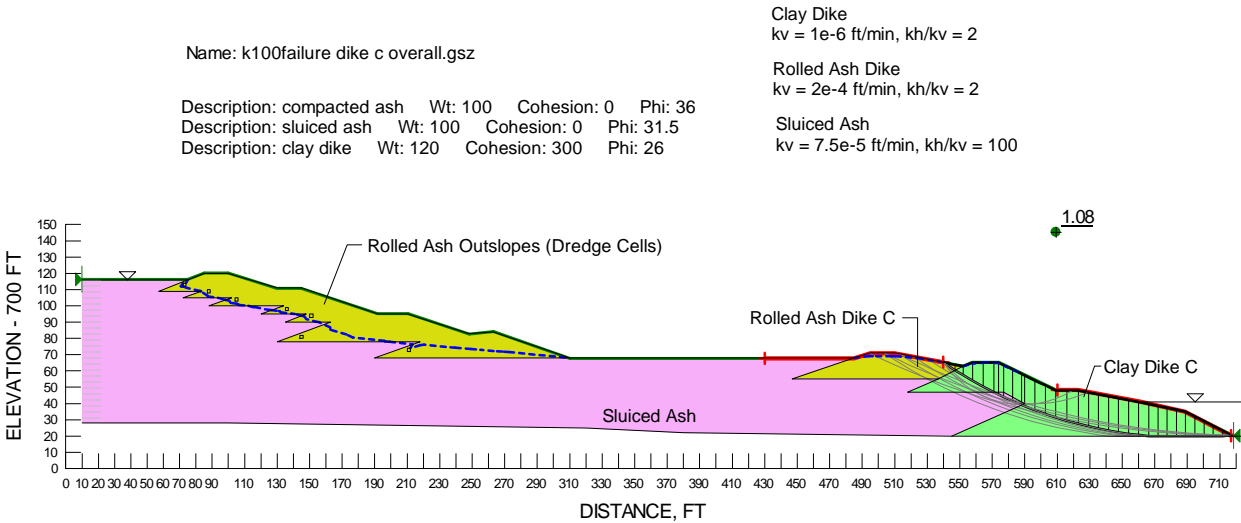
Figure 13. Results of stability analysis for effective stress condition with $k_h/k_v = 100$ in sluiced ash and minimum factor of safety = 1.08 for the overall slope of Dike C (for case with sluiced ash elevation = 816 feet in Kingston Dredge Cells), which indicates the entire Dike C structure is near collapse

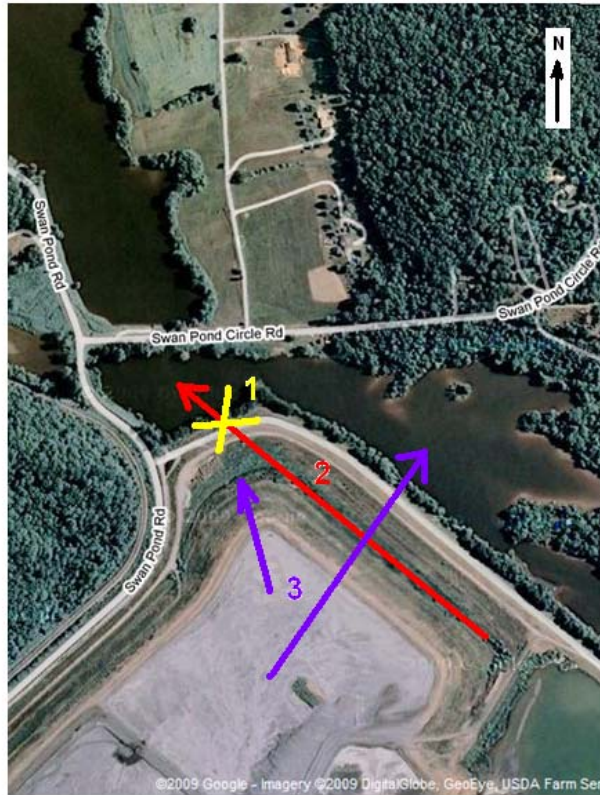
Possible Scenario of Failures Triggered by Dike C Rupture

One explanation is that Dike C ruptured at its northwestern limb. The excess pore water seepage pressure could then relieve itself through the breach, resulting in the failure of the sluiced ash between Dike C and the downstream toe of the dredge cells in a northwesterly direction. Subsequent failure of the dredge cells due to undermining of its foundation could then have progressed in a northeasterly direction, as would be expected, with subsequent spreading of the failed material due to gravity after it reached Watts Bar Lake. The sequence of the failure, based on the results of steady-state seepage and stability modeling according to effective stresses and post-failure aerial photographs, is shown on Figure 14.

1. Undrained hinge of Dike C in area of original crest and first raising ruptured due to high pore water seepage pressure (X marks the spot).
2. Exposed sluiced ash with underlying bottom ash lenses under high pore water seepage pressure failed explosively through the breach, causing undermining of the toe of the dredge cells.
3. Progressive slope failure of dredge cells resulting from undermining of toe. Each slope failure disrupts seepage path of bottom ash lenses in sluiced ash, resulting in increased pore water pressure and failure of subsequent slope until angle of failed mass reaches equilibrium.

Figure 14. Illustration of possible scenario of failures, as triggered by Dike C rupture, based on results of steady-state seepage and stability analysis for effective stress conditions

Based on a cursory review of TVA's forensic study report, the relic survey corroborates the failure scenario triggered by the Dike C rupture shown on Figure 14. Nevertheless, the results of my analysis need to be tested against additional field evidence not available to me. Were any of the "old dewatering wells" and "dewatering well overflowing redwater" referenced in the 2009 inspection report located in Dike C? Were any piezometers installed beneath Dike C within the failure zone, and were any of those piezometers being monitored? Could the references to "redwater" indicate the presence of iron from pyrites in the ash? If so, did the dewatering wells eventually clog due to iron deposition, thus reducing their effectiveness? When the valves were closed on the dewatering wells during the October 2008 inspection, what water levels were measured and were the valves re-opened after the inspection?

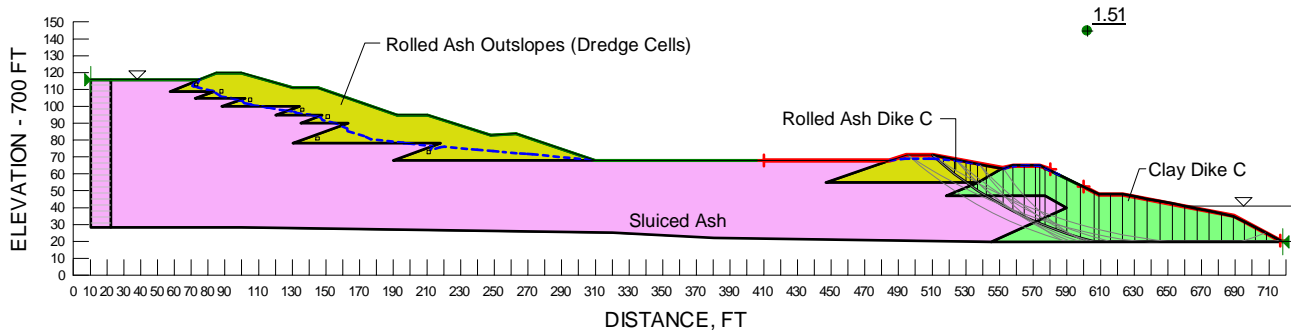
Ironically, a stability analysis performed using undrained strength, as suggested by TVA's forensic team, incorrectly predicts a stable Dike C regardless of the pore water pressure in the sluiced ash as shown on Figure 15.

Figure 15. Results of stability analysis for Dike C using undrained strength as suggested by TVA's forensic team with computed minimum factor of safety = 1.51, which indicates stable condition, whereas steady-state seepage and stability analysis using effective stresses predicts failure.

Answers to these and many other questions are important, and will undoubtedly foment new questions that need answering in order to understand the cause of the Kingston failure so such situations can be avoided or mitigated in the future. As illustrated by Figure 15, use of undrained shear strength to analyze the stability of undrained hinges at other hydraulic fill sites as suggested by TVA's forensic study report is dangerous and not recommended.

WARNING: Do not use undrained shear strength to analyze stability of undrained hinges (i.e. analyzing the stability of undrained hinges using undrained shear strength is comparable to making chicken salad using chicken droppings... trust me, it won't work).
